Australian Government
Department of Defence
Defence Science and
Technology Organisation

Fatigue Crack Initiation from Pitting Introduced during the Anodising Process

DSTO-TR-2729

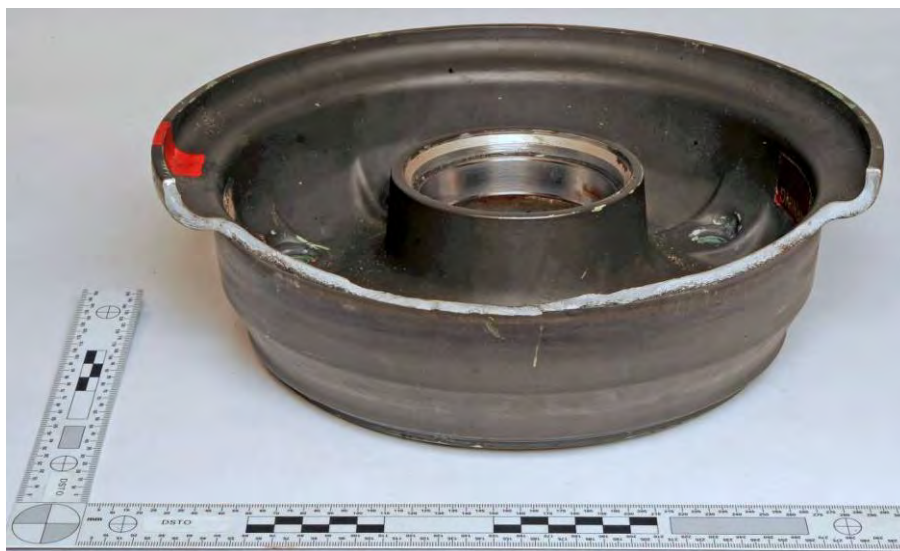
The left hand forward inboard wheel from an ADF rotary wing aircraft was found to be fractured during scheduled Daily Flight Servicing [8]. Figure 1 shows the wheel following removal of the tyre. A section comprising approximately one third of the circumference of the rim had broken away from the wheel at the bead seat and was located on the taxiway. The wheel had been in service for 1798 airframe hours (AFHRS) and was manufactured from aluminium alloy 2014-T6 with a sulphuric acid anodising surface treatment.

Figure 1. Photograph of the wheel following removal of the tyre. A section comprising approximately one third of the circumference had separated from the wheel at the bead seat.

Failure of the wheel occurred at the bead seat radius, which is typically a region of high bending stress and is therefore prone to initiation and growth of fatigue cracks, with small surface defects providing the crack initiation sites. Operational stresses arising during aircraft landing and taxiing provided the driving force for crack propagation.

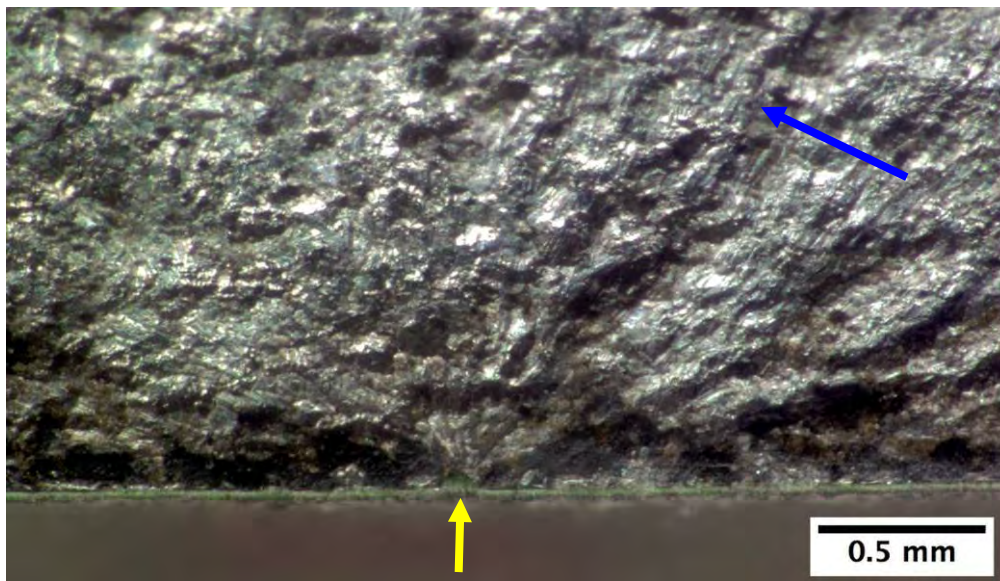
Examination of the fracture surface revealed the presence of progression marks and tear bands, indicative of fatigue cracking, see Figure 2. The area of fatigue cracking extended approximately 85 mm around the circumference of the wheel before final tensile failure occurred. It was observed that numerous fatigue cracks had initiated on the outer surface of the wheel and propagated inwards. Higher magnification examination revealed surface etch pits up to 40 μm diameter and 40 μm depth, and corrosion pits up to 300 μm in diameter and 100 μm in depth, at the origins of the fatigue cracks. Paint was observed within these pits, see Figure 3.

Figure 3. Photograph of a fatigue crack observed on the fracture surface. A fatigue progression mark is indicated with a blue arrow. The pit at the origin of the crack (approximately 40 μm in depth), which was observed to have been painted, is indicated with a yellow arrow.

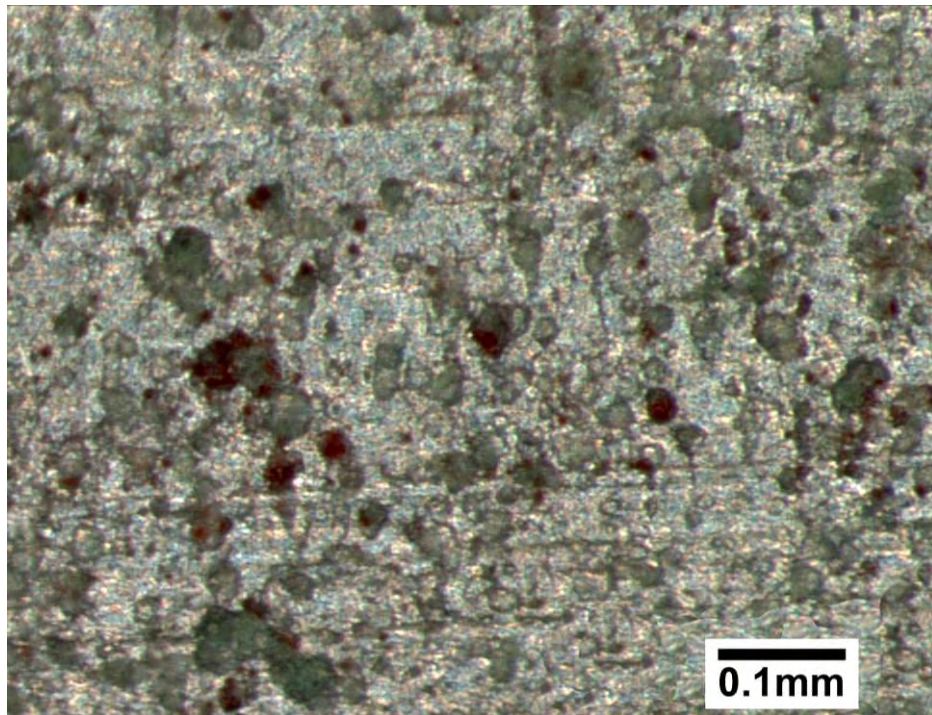
Following removal of the paint from a section of the wheel, it was observed that the surface of the wheel was extensively pitted, with smaller rounded etch pits and larger corrosion pits present, see Figure 4 and Figure 5. The size of these pits was consistent with the pits observed at the fatigue crack origins.

Figure 4. Photograph of the outer surface of the wheel following paint removal. The surface exhibited extensive rounded etch pits up to 40 μm diameter.

Fatigue cracking had initiated from etch and corrosion pits present on the wheel's external surface. The etch and corrosion pits were anodised and painted, indicating that they had formed prior to anodising. The existence of etch pits over all surfaces suggests that they likely formed when the wheel was immersed in a bath during a pre-anodising process. The corrosion pits likely grew from etch pits due to environmental exposure prior to surface finishing.

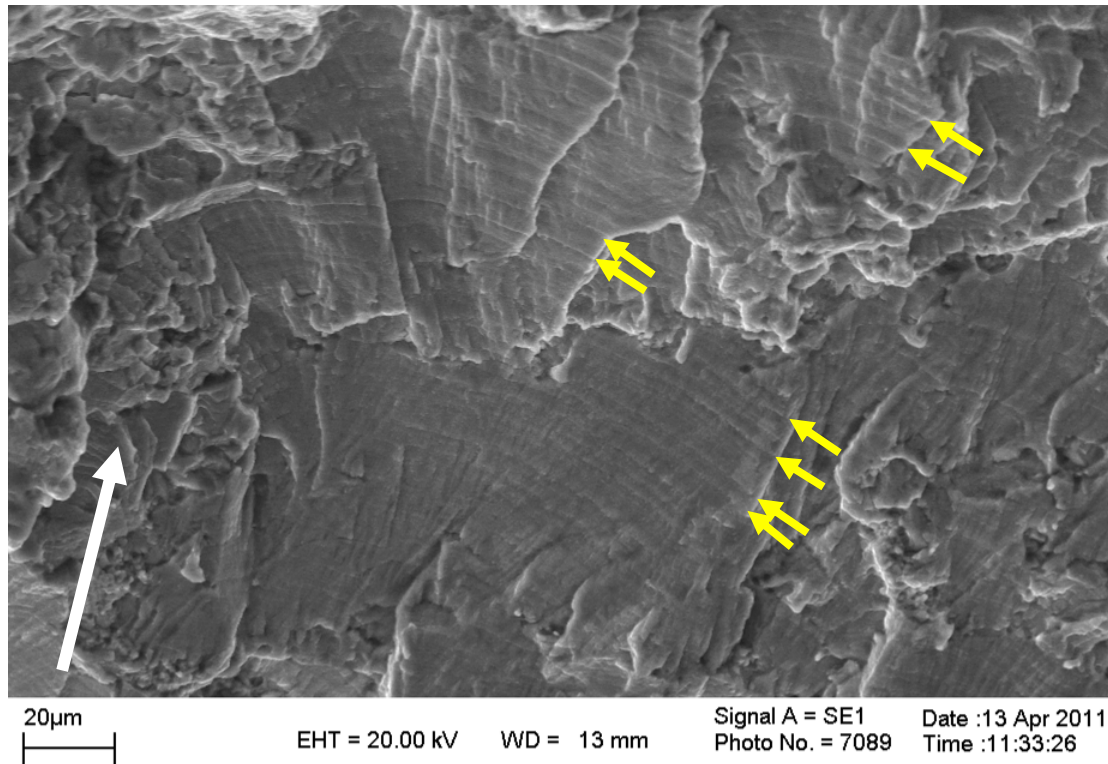
Scanning Electron Microscope (SEM) examination of the fracture surface confirmed that the failure mode was consistent with fatigue, with progression marks present over the fracture surface, see Figure 6. Examination of the corrosion and etch pits present at the crack initiation sites revealed that they had been anodised and painted, see Figure 7 and Figure 8, which indicated they were present at production.

Figure 6. SEM photograph of the fracture surface on which numerous progression marks were observed, examples indicated with yellow arrows. Crack growth direction is indicated with a white arrow.

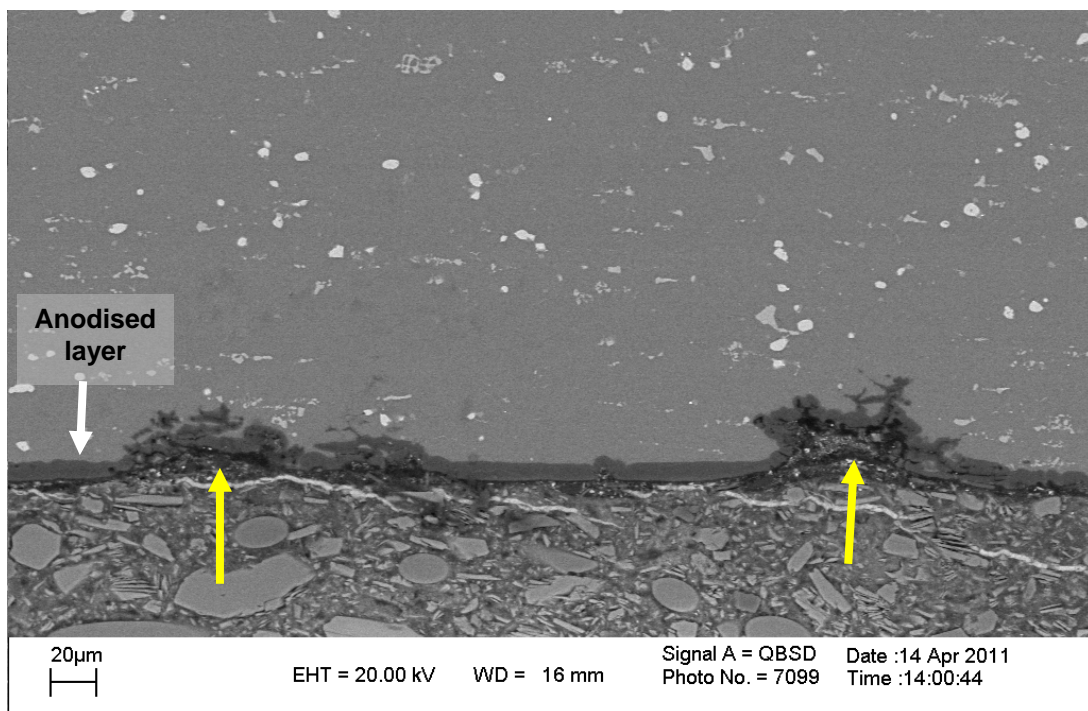
Figure 8. SEM photograph showing two corrosion pits in cross-section, indicated with yellow arrows. The surfaces of the pits were found to have been anodised.

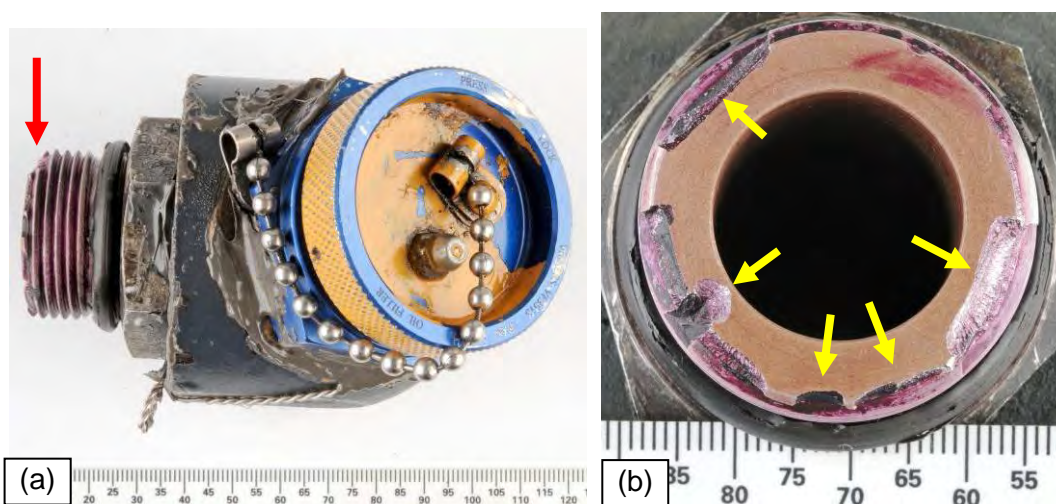
During removal of the gearbox oil filler assembly from an ADF rotary wing aircraft, the first thread of the oil filler adapter was found to have fractured [9]. Two failures of this type had previously occurred. The adapter, shown in Figure 9, was manufactured from aluminium alloy L168-T6 (equivalent to AA 2014) with a chromic acid anodising surface treatment.

Figure 9. Photographs of the oil filler adapter as received. The first thread was fractured, as indicated with a red arrow in (a). Fracture occurred in several locations, examples indicated with yellow arrows in (b).

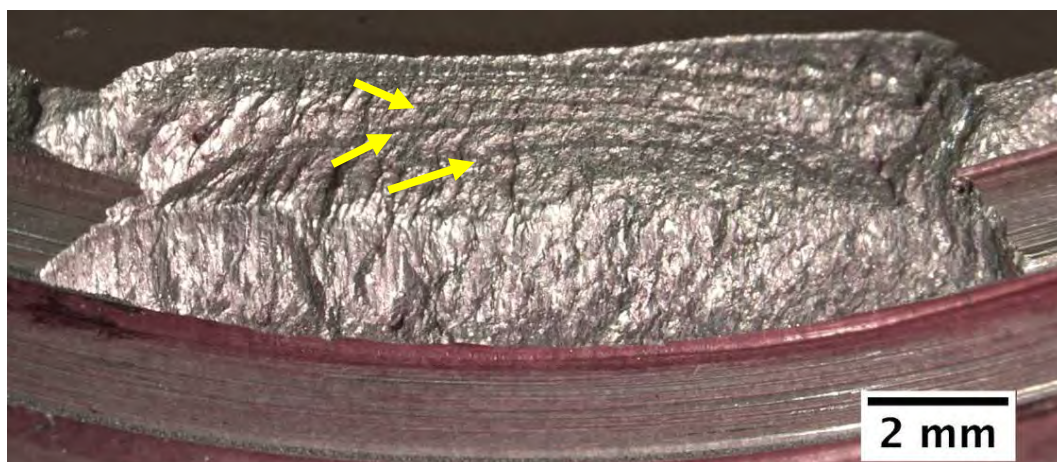
Following cleaning, the fracture surfaces on the first thread were examined and found to be consistent with fatigue cracking, see Figure 10. The cracks had initiated at corrosion pits up to 80 μm diameter and 30 μm depth at the thread roots, see Figure 11. SEM examination of the fracture surfaces confirmed cracking was via fatigue, with numerous progression marks present, see Figure 12 for example, and corrosion pits present at the crack initiation sites, see Figure 13.

Figure 10. Photograph of the cracking present on the first thread. The cracking originated at the thread root and was consistent with fatigue. Examples of progression marks are indicated with yellow arrows.

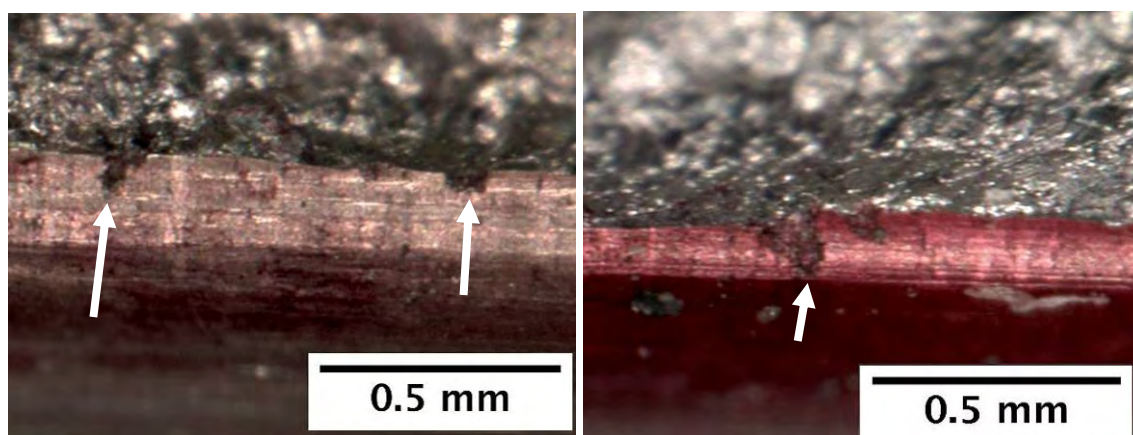
Figure 11. Photographs of pitting (arrowed white) observed at the initiation sites of the fatigue cracks. Corrosion pits up to 80 μm diameter and 30 μm depth were observed.

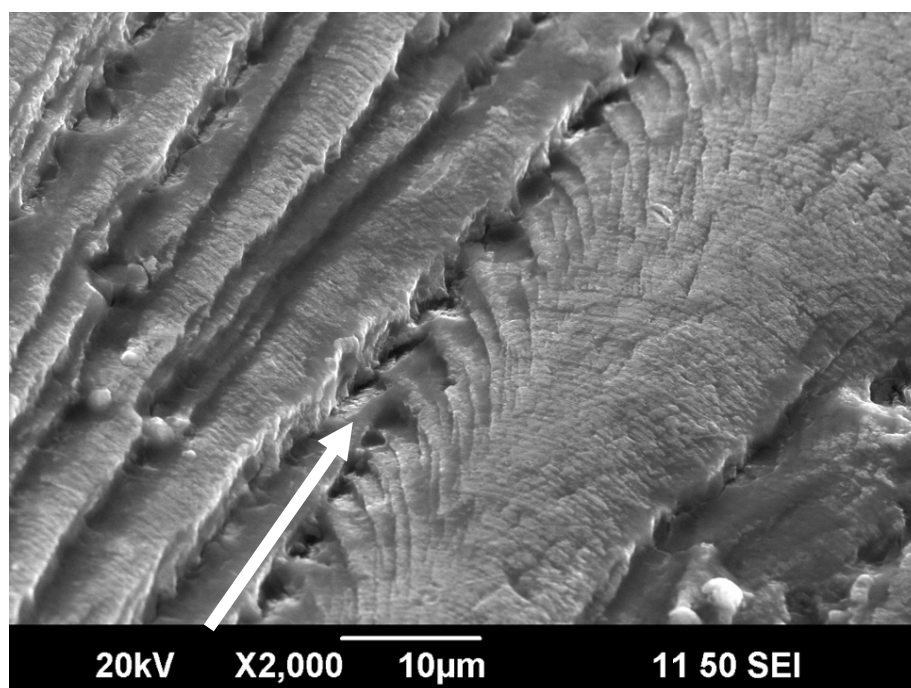
Figure 12. SEM photograph of the fracture surface showing the numerous progression marks, appearing as a series of curved bands on the surface. Crack growth direction is indicated with a white arrow.

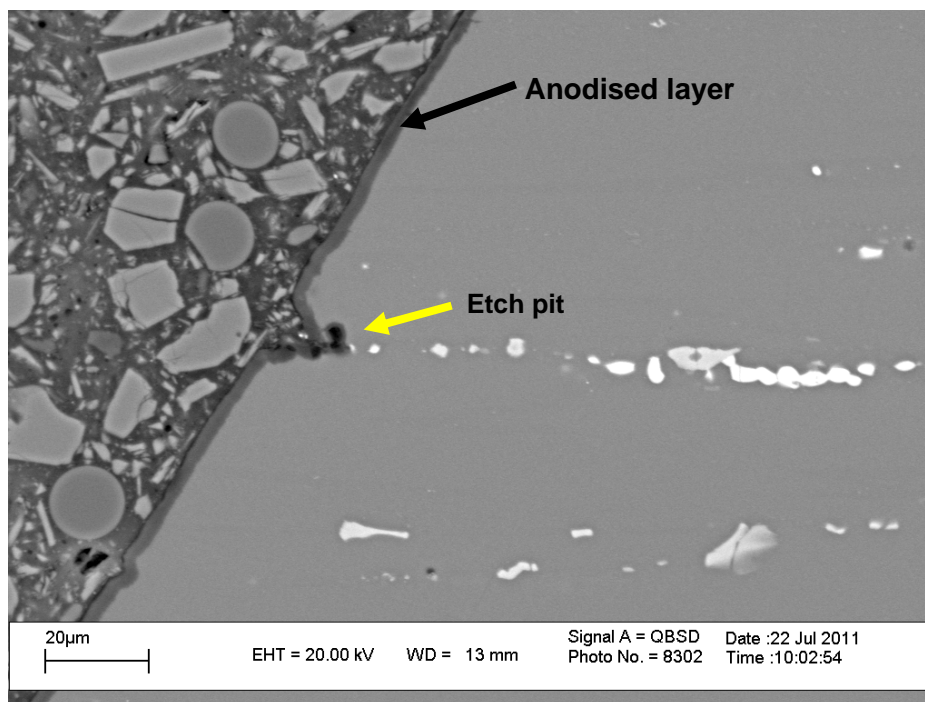
Cross-sections cut through the threaded section of the oil filler adapter revealed the presence of fine etch and larger corrosion pits on the threads, see Figure 14 and Figure 15. The surfaces of the etch pits were anodised while the corrosion pits were only partially anodised, which indicated that further corrosion and growth of the pits had occurred following anodising.

The etch pits would provide ideal sites for the initiation of corrosion pits due to environmental contamination prior to anodising. In addition, the presence of the etch pits may have caused discontinuities in the anodised surface layer, making the component susceptible to localised corrosion and corrosion pitting following anodising.

Figure 14. SEM photograph of etch pitting observed in a polished metallographic cross-section through the oil filler adapter. The surfaces of the pits were anodised. Pits were observed to be up to 12 μm in diameter and 10 μm in depth.

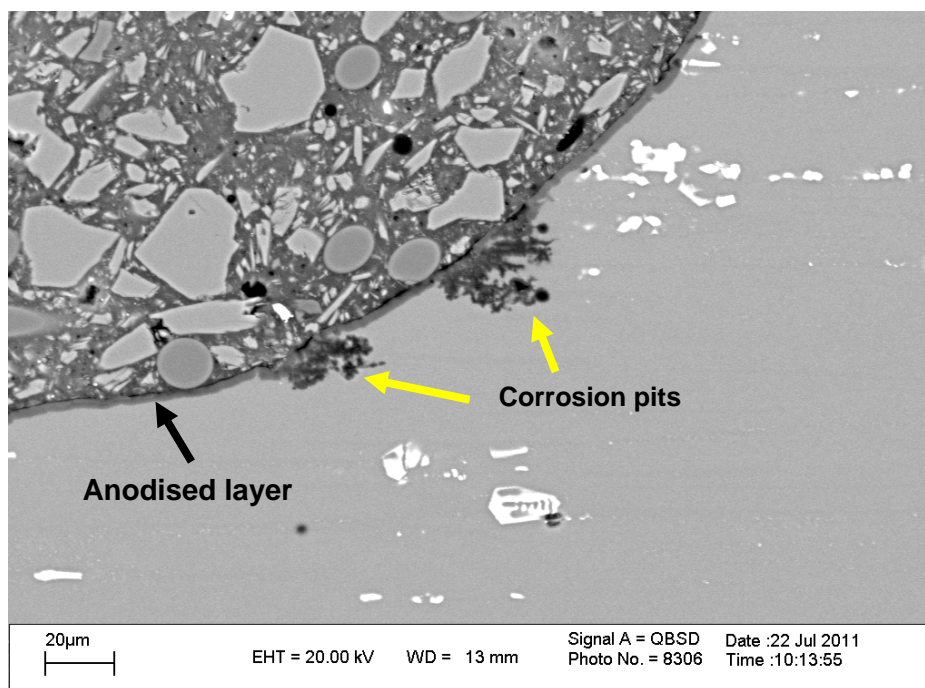
Figure 15. SEM photograph of corrosion pitting observed in a polished metallographic cross-section through the oil filler adapter. An anodised layer was present at the surface and within the pits.

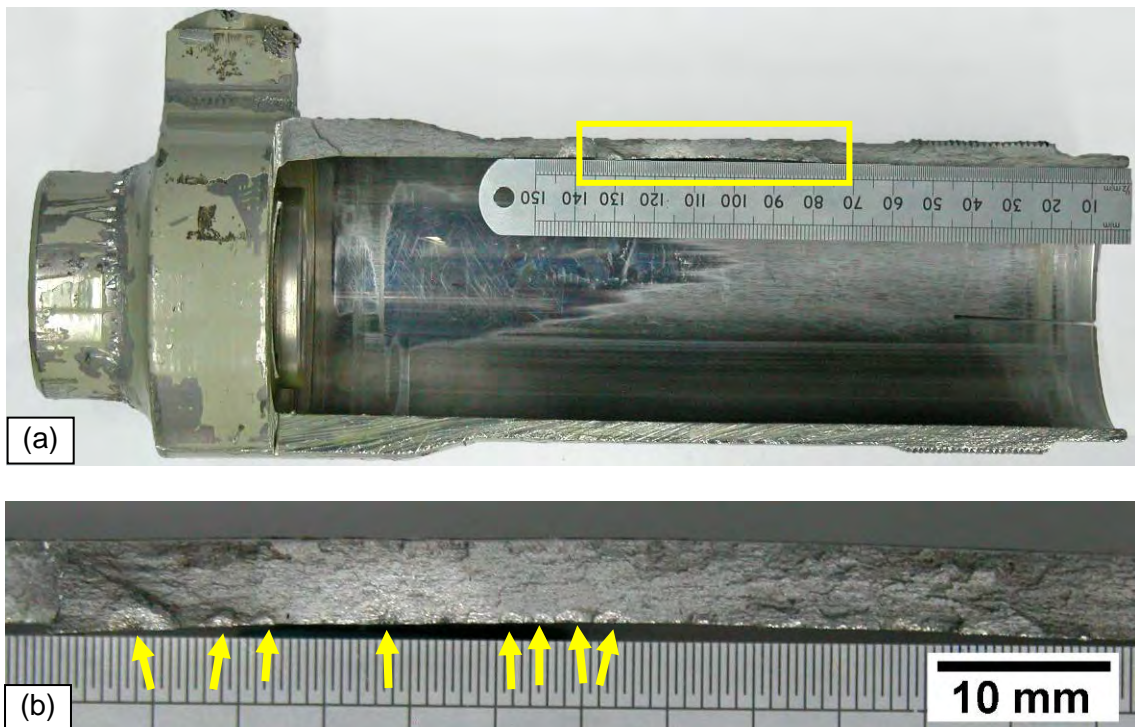
Examination of the fracture surfaces revealed the presence of multiple cracks in the wall of the cylinder, see Figure 17. Progression marks were present on the fracture surfaces indicating that the cracking had propagated via fatigue. Based on the orientation of the progression marks, the crack originated from the bore of the cylinder and propagated towards the outer surface.

Figure 17. Photographs showing the fracture surface of the hydraulic cylinder. The area marked with a yellow box in (a) is shown at higher magnification in (b). Multiple crack initiation sites were observed, with examples indicated with yellow arrows.

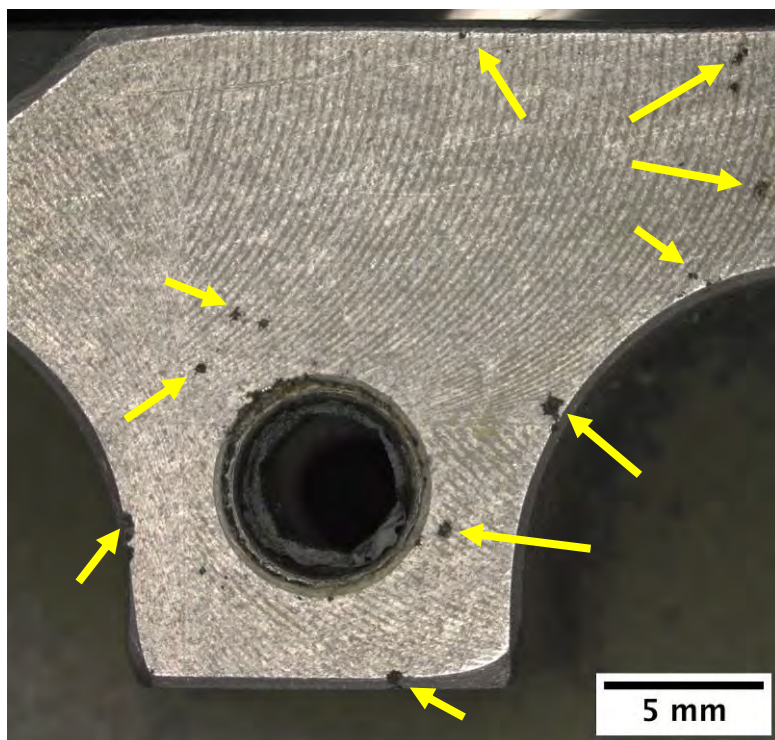
Examination of the two rescue hoist arms revealed the presence of fine etch pits on all surfaces. The pits were typically 50 – 100 μm in diameter, see Figure 21. In addition to the fine etch pitting, a distribution of larger corrosion pits was observed on the outer surfaces of the rescue hoist arms, see Figure 22. The locations of the corrosion pits were generally consistent between the two rescue hoist arms, see Figure 23. The corrosion pits were up to 5 mm in length, with some containing dark coloured deposits and others being filled with paint or containing paint particles that were consistent in size and shape with the paint observed within the etch pits, see Figure 24.

Figure 22. Photograph showing examples of the corrosion pits observed on the body of the rescue hoist arm, indicated with yellow arrows. Corrosion pits up to 5 mm in length were observed.

Corrosion pits were also present on both rescue hoist arms. The large size and localised nature of the corrosion pits suggested that they formed due to exposure to a surface contaminant. As the locations of the corrosion pits were consistent between the two rescue hoist arms and limited to the exterior surface of the body, it is likely that contamination occurred during a process which all parts were subjected to during manufacture or storage, for example parts handled with contaminated gloves or equipment, or stored on contaminated racks.

Due to the presence of significant surface etch pits and localised corrosion pits, the rescue hoist arms were considered no longer fit for purpose. The presence of the etch pits and, in particular, the larger corrosion pits introduced unquantifiable stress concentrations that could initiate cracks during subsequent in-service loading, both cyclic and sustained. As such, all rescue hoist arms from the same manufacturing batch were rejected.

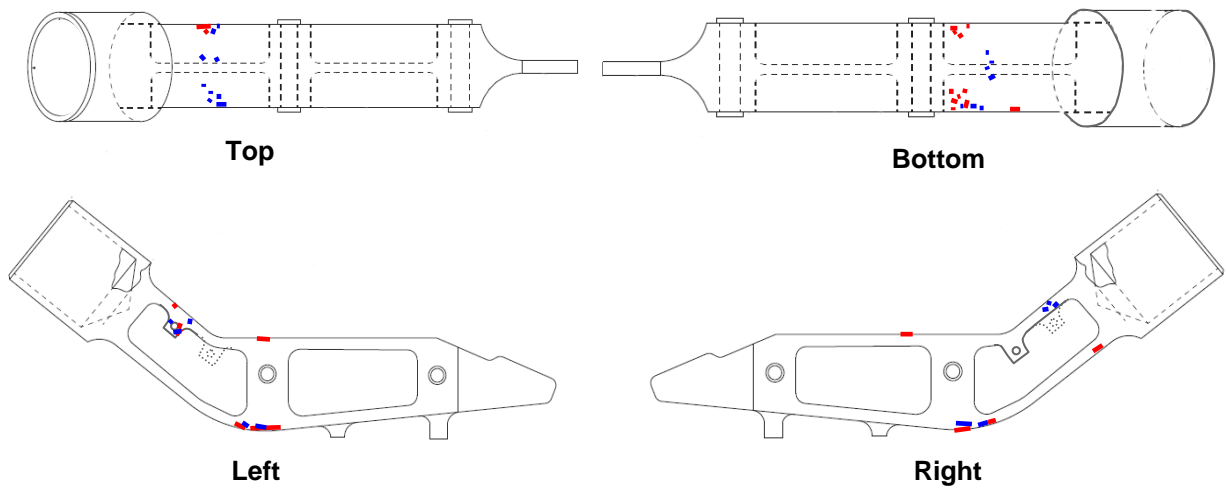
Figure 23. Diagrams showing locations of corrosion pits on each face of the rescue hoist arms. Red points indicate corrosion pits on rescue hoist arm 1 and blue points indicate corrosion pits on rescue hoist arm 2. Locations were generally consistent between the two rescue hoist arms.

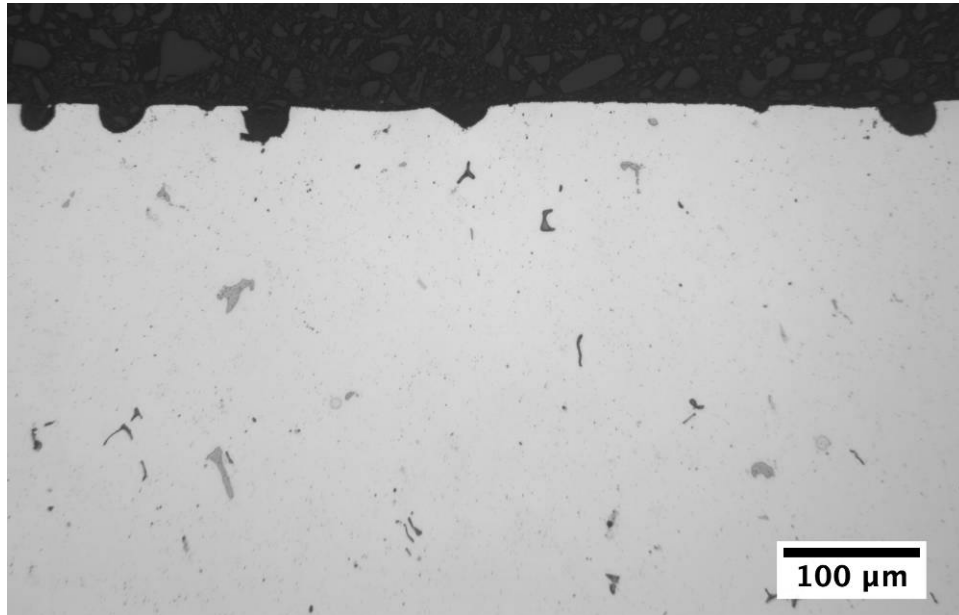
Cross-section examination of the etch pits revealed they had a rounded shape and a typical depth of approximately 25µm, see Figure 25. An anodised layer was observed on the surface of the etch pits, see Figure 26. Examination of the corrosion pits in cross-section revealed that the pits were in the order of 300 µm in depth and had a branched, irregular structure, see Figure 27 for example.

Figure 25. Micrograph of a cross-section from a rescue hoist arm showing the etch pits were up to 25 µm in depth.

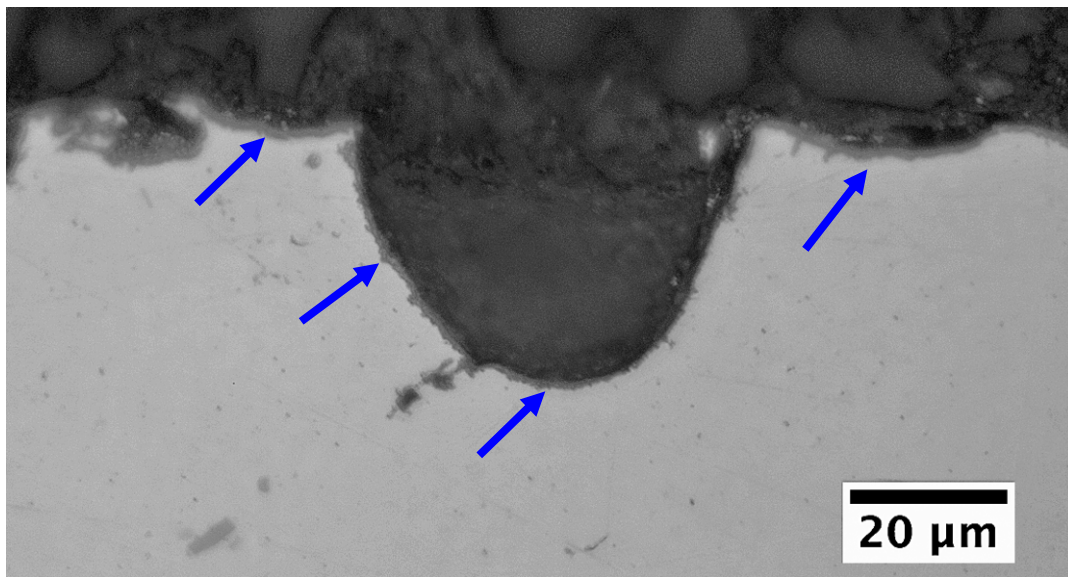
Figure 26. Micrograph of a rescue hoist arm in cross-section showing the presence of an anodised layer on the surface of the component and within the etch pits, as indicated with blue arrows.

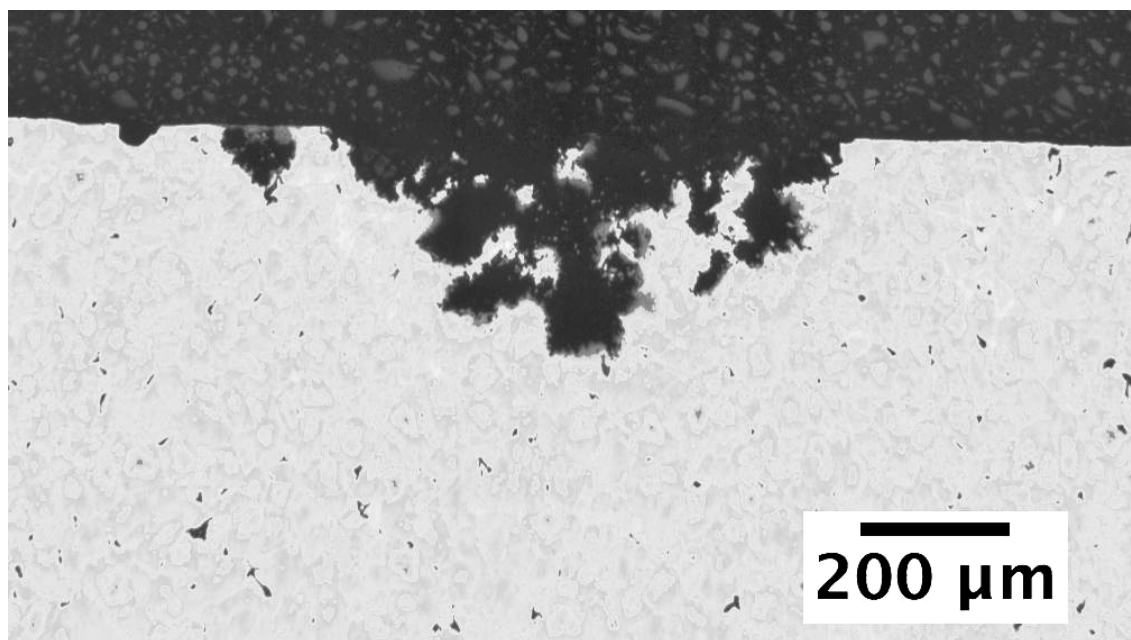
Figure 27. Micrograph of a rescue hoist arm in cross-section showing the corrosion pits had a branched and irregular structure.
